NOTIFICATION

N-042619

DATE ISSUED: 04/26/2019
DATE EFFECTIVE: 04/26/2019
SUPERSEDES NOTICE: N/A
SUBJECT: Handling Instructions for Aircraft Controls in High Wind Conditions
AIRCRAFT AFFECTED: **MODEL:** A5
S/N: All
REQUIRED ACTION: None
TIME OF COMPLIANCE: Immediately
REVISION HISTORY: Initial Release

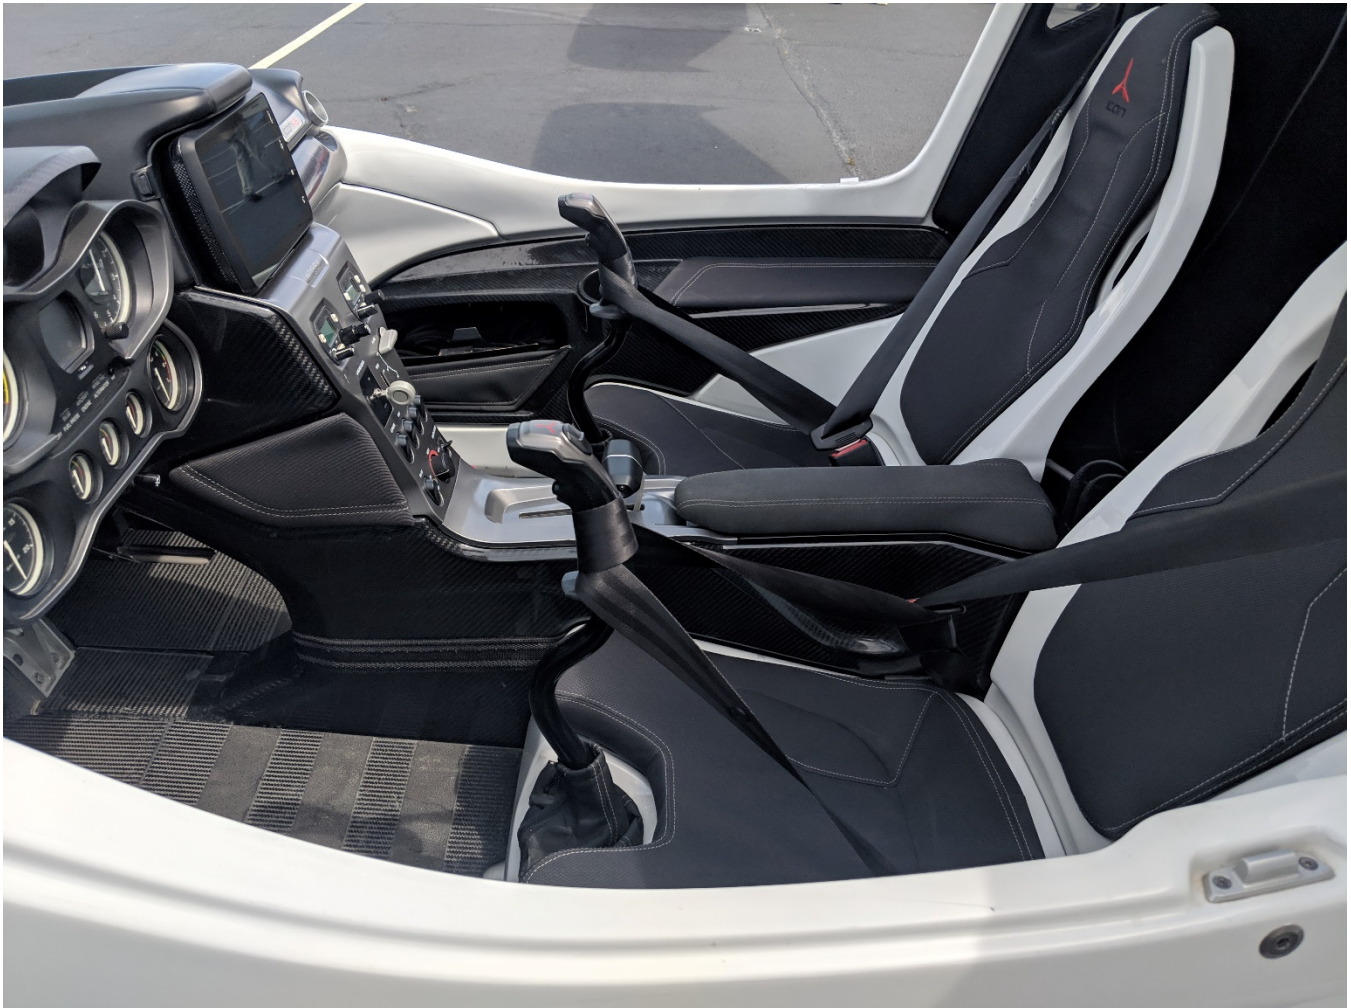
Figure 1: Ailerons and Elevator gust locked with both seatbelts

1. It is best to find a location to park the aircraft indoors such as a hangar.
2. If parking or tying the aircraft down outside when high winds are present, it is likely the controls will bang against the stops.
3. If it is suspected high winds will be present, it is best to orient the aircraft into the prevailing wind. When leaving the aircraft unattended on the ramp, the flaps should be fully extended to prevent them from moving.
4. The seatbelt should also be secured around both control sticks to prevent the ailerons and elevator from moving. To properly hold the stick in place, loop each seatbelt twice around the hand grip portion of its respective control stick. If the seatbelt is looped around the shaft of the

stick instead of the hand grip, the control system will not be properly secured. See Figures 1 and 2 below.

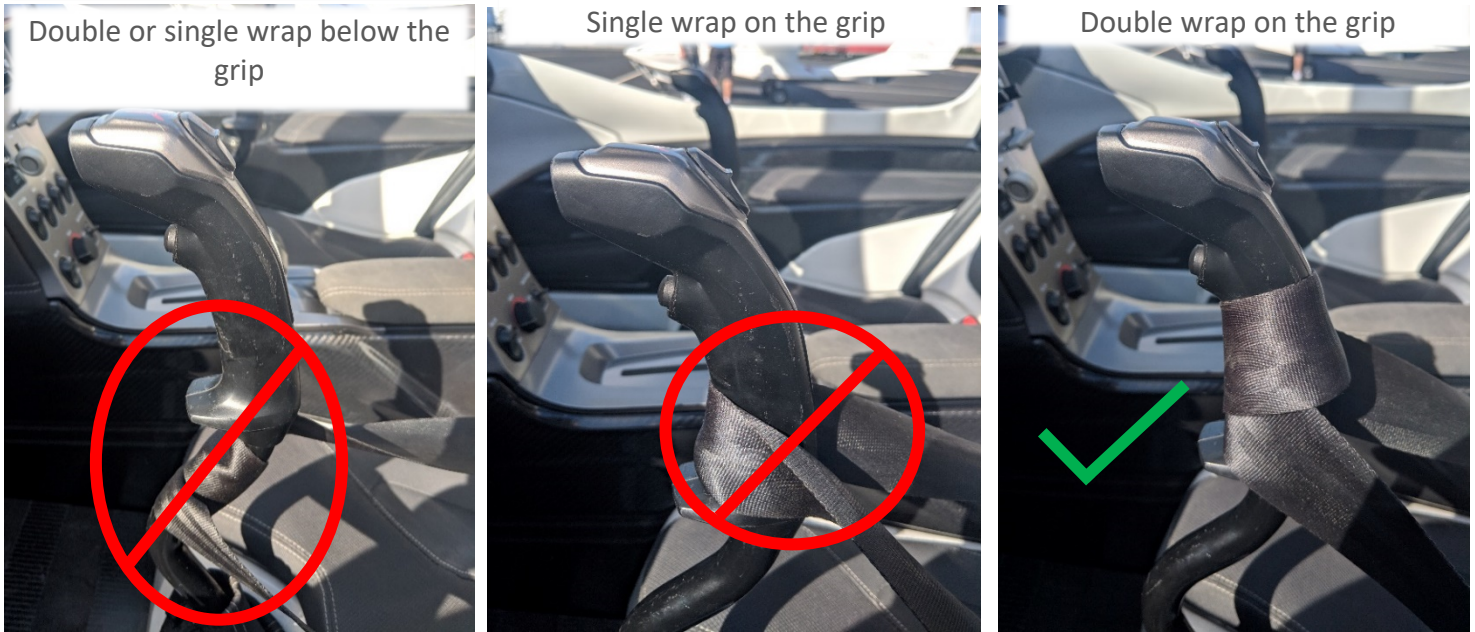
Figure 2: Seatbelt should be double looped around control stick grip. Single looping around grip, or double looping around stick shaft will not properly secure control surfaces.
