SERVICE BULLETIN

SB-110521 REV A

DATE ISSUED: 12/13/2021
DATE EFFECTIVE: 12/13/2021
SUBJECT: Fuel Pump Connector/Contact Replacement
AIRCRAFT AFFECTED: **MODEL:** A5
S/N: 00093, 00095, 00114, 00122, 00126, 00134, 00141, 00144
REQUIRED ACTION: Fuel pump connector/contact replacement.
TIME OF COMPLIANCE: Replace at next service interval.

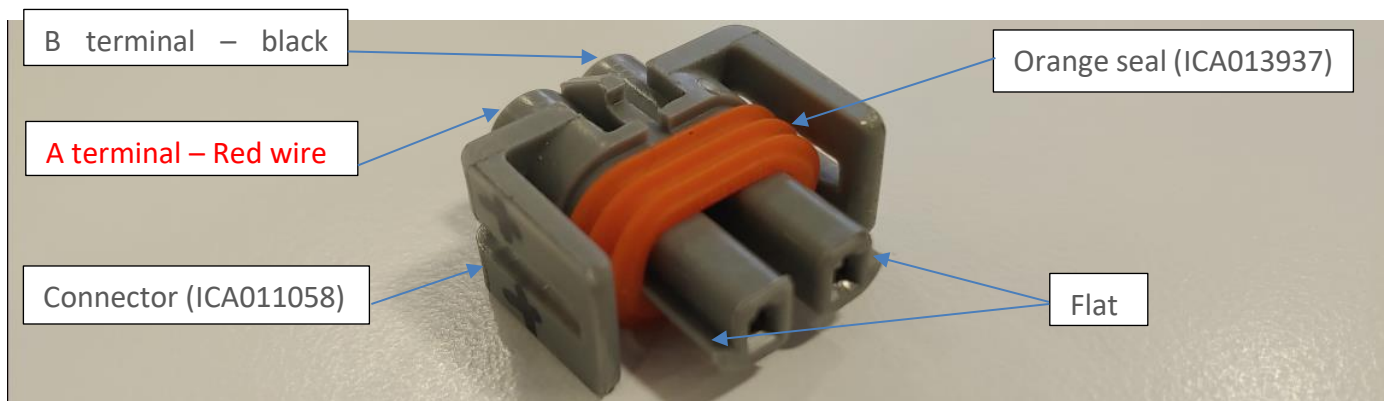
Figure 1: Connector wire locations

have either a blue seal or an orange seal in this location. The replacement connector must have the orange seal installed.

7. Install 1 each blue wire seal (ICA012801) on each wire in the same orientation as the seals that were removed and slide away from the end of the wire.
8. Strip ¼” of insulation from each wire.
9. Align the blue wire seal with the end of the wire insulation.
10. Position the wire end in the terminal (ICA011062) as shown in Box 4.
11. Optional depending on the tool used: using the tool position for 16 gauge wire, crimp core wings first, then insulation wings using crimp tool 12085271 or equivalent. If the crimping tool is properly equipped, the seal crimp and the core crimp can happen simultaneously.
12. Install 1 each orange connector seal (ICA013937) onto the new connector body in the same location and orientation as the seal on the original connector. See **Figure 1**. **Note: The original connector may**

13. Slide the new connector contact secondary lock (ICA011057) onto the wires.
14. Insert the contacts into a new connector (ICA011058) with the same location and orientation that the wires were in when removed from the old connector. The contact on the black wire inserts into the “B” side of the connector and the contact on the red wire inserts into the “A” side. See **Figure 1**. Ensure that the contacts positively seat into the connector body. A “click” is heard when the contact seats and a gentle tug on the wire confirms.
