<h1 style="margin: 0;">SERVICE BULLETIN</h1> <h2 style="margin: 0;">SB-112222-A</h2>
--

ID NUMBER & REVISION: SB-112222-A
SUBJECT: Flap Gast Strut
RELEASE DATE: 10 February 2023
EFFECTIVE DATE: 10 February 2023
SUPERSEDES NOTICE: N/A
AIRCRAFT AFFECTED: **MAKE & MODEL:** ICON A5
SERIAL NUMBERS: 00001, 00003 – 00136, 00138 – 00146, 00148 –
00150, 00152 – 00159, 00161, 00163, 00166, 00170,
00172 – 00174, 00176, 00177
REQUIRED ACTION: Inspect the flap gas strut for proper installation of the ball socket and rod
end.
TIME OF COMPLIANCE: At the next service interval.
REVISION HISTORY: A Initial Release

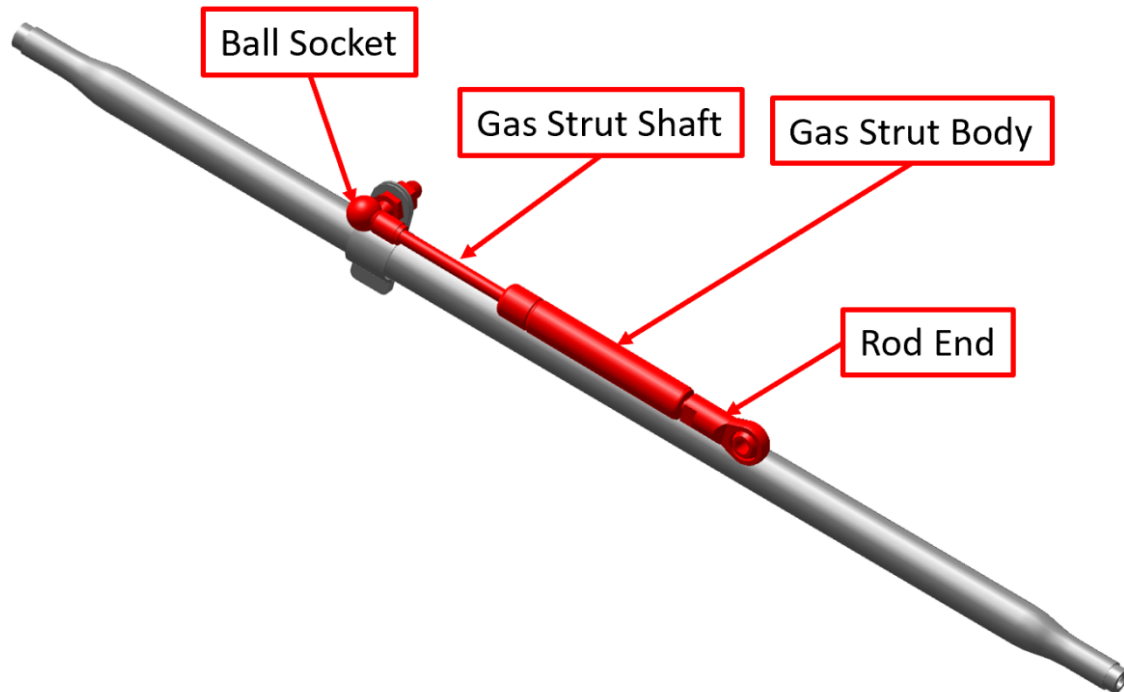
Figure 1 Flap Gas Strut

2. Locate the piston rod end with the ball socket attached.
 - a. See Figure 1

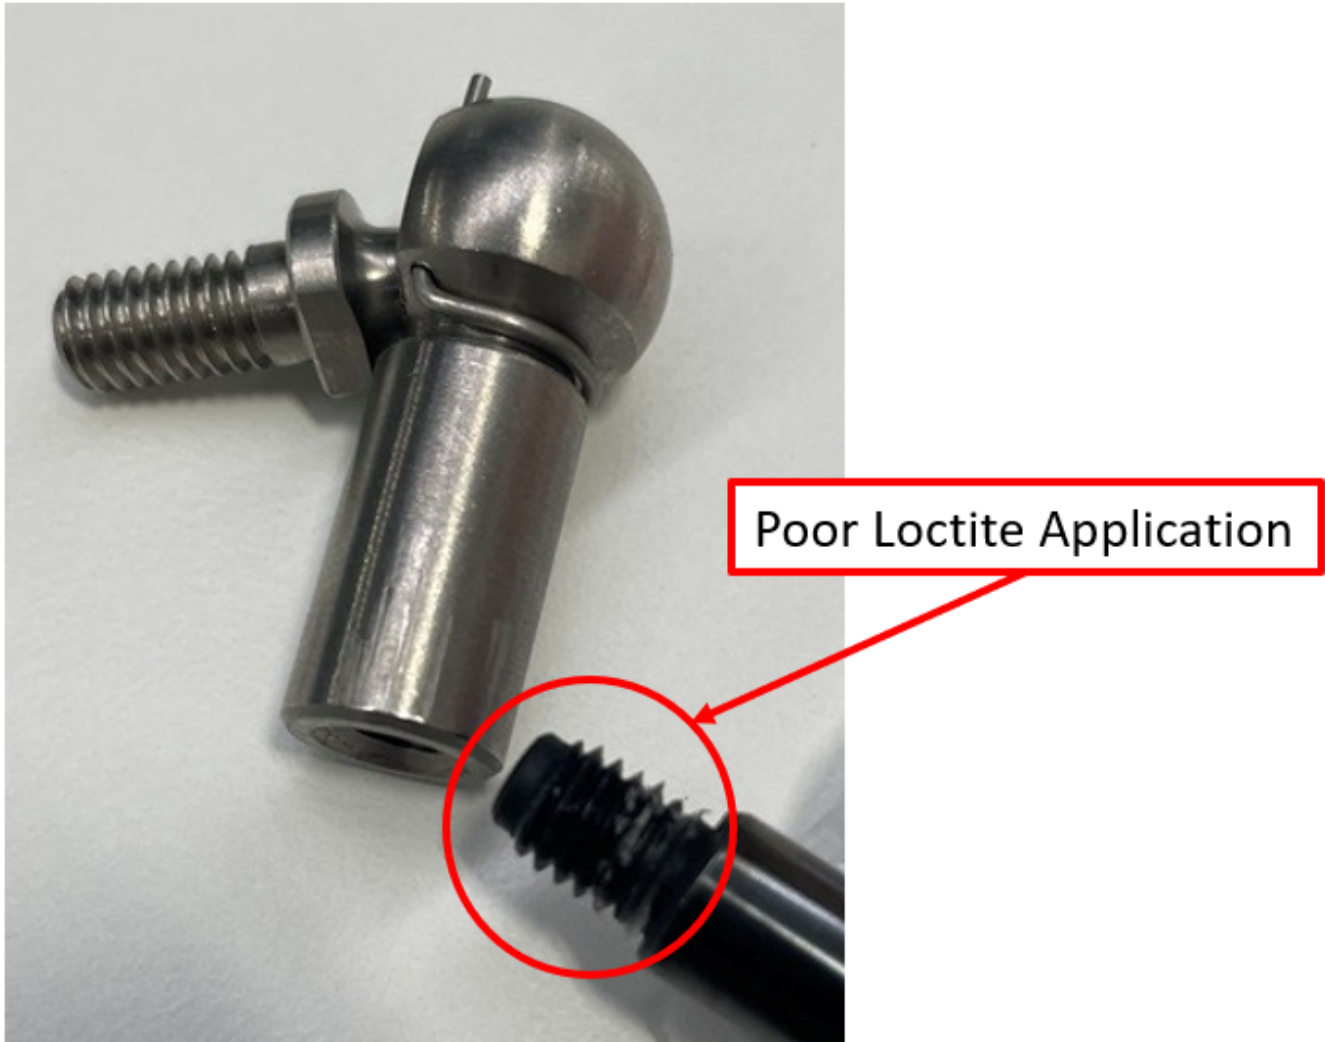
Figure 2 Poor Loctite Application

It was recently discovered that the ball socket (installed on the gas strut shaft) and the rod end (installed on the gas strut body) did not have the proper thread adhesion applied. In addition, some flap gas struts did not have the ball socket and rod end installed on the correct end of the gas strut. Failure to install the ball socket or rod end on the correct gas strut end and/or correctly apply thread adhesion could result in the flap gas strut to loosen. This Service Bulletin provides the inspection and repair instructions to address this issue.

3. Attempt to rotate the ball socket relative to the gas strut shaft.
4. If the ball socket easily rotates and/or the threads have lost adhesion, remove the ball socket completely from the rod end.
 - a. See Figure 2 for poor Loctite application.
5. Attempt to rotate the gas strut body relative to the rod end.
6. If the gas strut body easily rotates and/or the threads have lost adhesion, remove the rod end from the gas strut body.
 - a. See Figure 2 for poor Loctite application.

7. Thoroughly clean the affected ball socket and/or rod end threads as well as the gas strut threads with isopropyl alcohol.
8. Apply Loctite 263 liberally to affected threads.
9. If ball socket end is affected, grasp gas strut body and hand tighten ball socket onto gas strut shaft until gas strut shaft rotates relative to the gas strut body.
10. If rod end is affected, grasp ball socket end and hand tighten rod end onto the gas strut body until gas strut body rotates relative to the ball socket.
11. Hand-tighten affected end of strut until the gas strut rotates.
12. Clean up excess Loctite.
13. Allow Loctite 263 to cure in accordance with manufacturer's instructions.
14. Install the Flap Gas Strut per the online [ICON Maintenance Manual](#)
 - a. Remove Flap Gas Strut ([100205](#))
