SERVICE BULLETIN

SB-122722-A

“I hereby certify the inspection and repair has been completed in accordance with Service Bulletin (SB-122722-A, NLG Actuator End Torque) and all the referenced documents. Potentially unclear procedures have been clarified with ICON Aircraft. The corrective action of this Service Bulletin (SB-122722-A) has been complied with (ref. FAA Exemption 10829B)”.

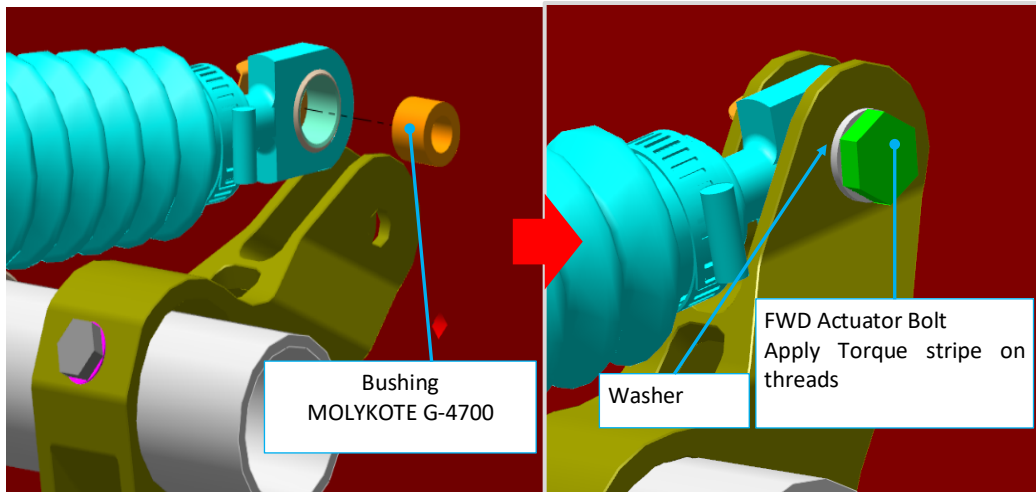
*Figure 4 FWD Actuator Bolt Install*

7. Remove FWD Actuator Bolt to validate Torque at FWD actuator Rod End, see Figure 4 for reference
 - a. Make note not to remove the bushing.
 - b. Verify and note the torque level on the jam nut.

10. Reinstall hardware securing actuator to bellcrank.
 - a. Verify bushing is installed.
 - b. Torque hardware to 53 in-lbs, see Figure 4.
11. Apply Molykote to the wrist pin and re-install through the NLG leg and NLG drag link as shown in Figure 2.
