SAFETY DIRECTIVE/ALERT

SD-031717 REV A

DATE ISSUED: 03/17/2017
DATE EFFECTIVE: 03/17/2017
SUPERSEDES NOTICE: N/A
SUBJECT: Elevator center hinge retention
AIRCRAFT AFFECTED: **MODEL:** A5
S/N: 00001 to 00019
REQUIRED ACTION: Install ball bearing using Loctite 603
TIME OF COMPLIANCE: Prior to Next Flight

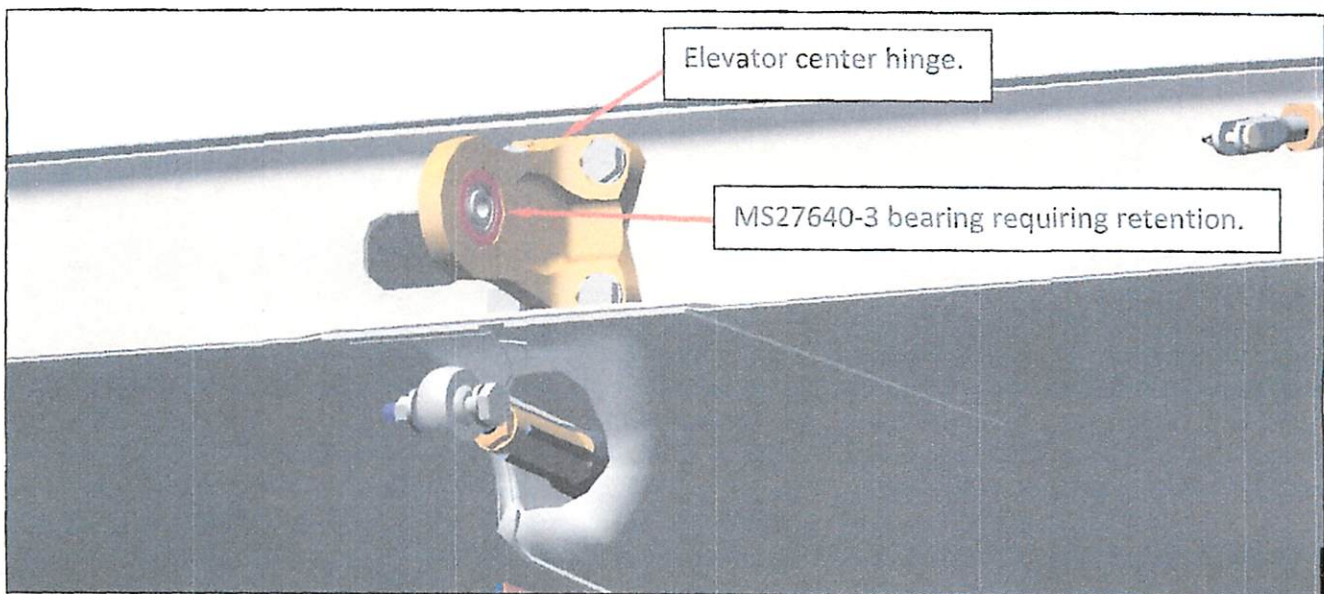
Figure 2: Elevator center hinge.

ICON has experienced several anomalies related to the functionality of the A5 pitch control system. Although none of these events individually have resulted in a safety of flight issue, ICON believes when assessed collectively could potentially have an impact to the safety of flight.

3. Inspect the installed bearing (MS27640-3) identified on Figure 2. If the bearing is firmly retained, the outer race is flush and square with the elevator center hinge surfaces, and there is evidence of Loctite 603 (Loctite 603 is light green in color and may have partially filled the chamfer on the bearing outer race) having been applied on installation, it is acceptable to leave the installation untouched (leave bearing installed, and skip steps 4 to 9 below). If there is any uncertainty at all, remove and replace the bearing in accordance with the following steps.

4. Remove the bearing (MS27640-3) from the elevator center hinge shown in Figure 2.
5. Visually inspect the surfaces of the bearing outer race, and the hinge bore to check for evidence of a broken Loctite bond. If any evidence of Loctite is found, and the bond has been broken in service, contact ICON Engineering prior to further repair action.

6. Clean the hinge bore to remove all foreign material (including any remnants of previous Loctite adhesive).
7. Ensure anodizing on bore surface remains intact. If anodizing is worn away replace the hinge bracket with a serviceable part.

8. Measure bore diameter at multiple locations. Ensure bore is within $\varnothing_{.7784}^{.7805}$ at all locations. If bore is out of these specified tolerance limits replace the hinge bracket with a serviceable part.

9. Install a replacement bearing (MS27640-3) to the bore using Loctite 603 retaining compound with Loctite 7471 activator. Surface preparation, application and cure to be in accordance with adhesive manufacturer's instructions.

10. Push by hand axially on the outer race of the bearing to ensure secure.
