SAFETY DIRECTIVE/ALERT

SD-043019-A

DATE ISSUED: 04/30/2019
DATE EFFECTIVE: 04/30/2019
SUPERSEDES NOTICE: SD-043019
SUBJECT: Parachute Strap Installation
AIRCRAFT AFFECTED: **MODEL:** A5
S/N: 00001 to 00021
REQUIRED ACTION: Inspect IPS bridle C-ends, reinstall if not looped through quick link properly
TIME OF COMPLIANCE: Within the next 10 hours of service
REVISION HISTORY Rev A – Corrects Signature statement and fixes page numbers

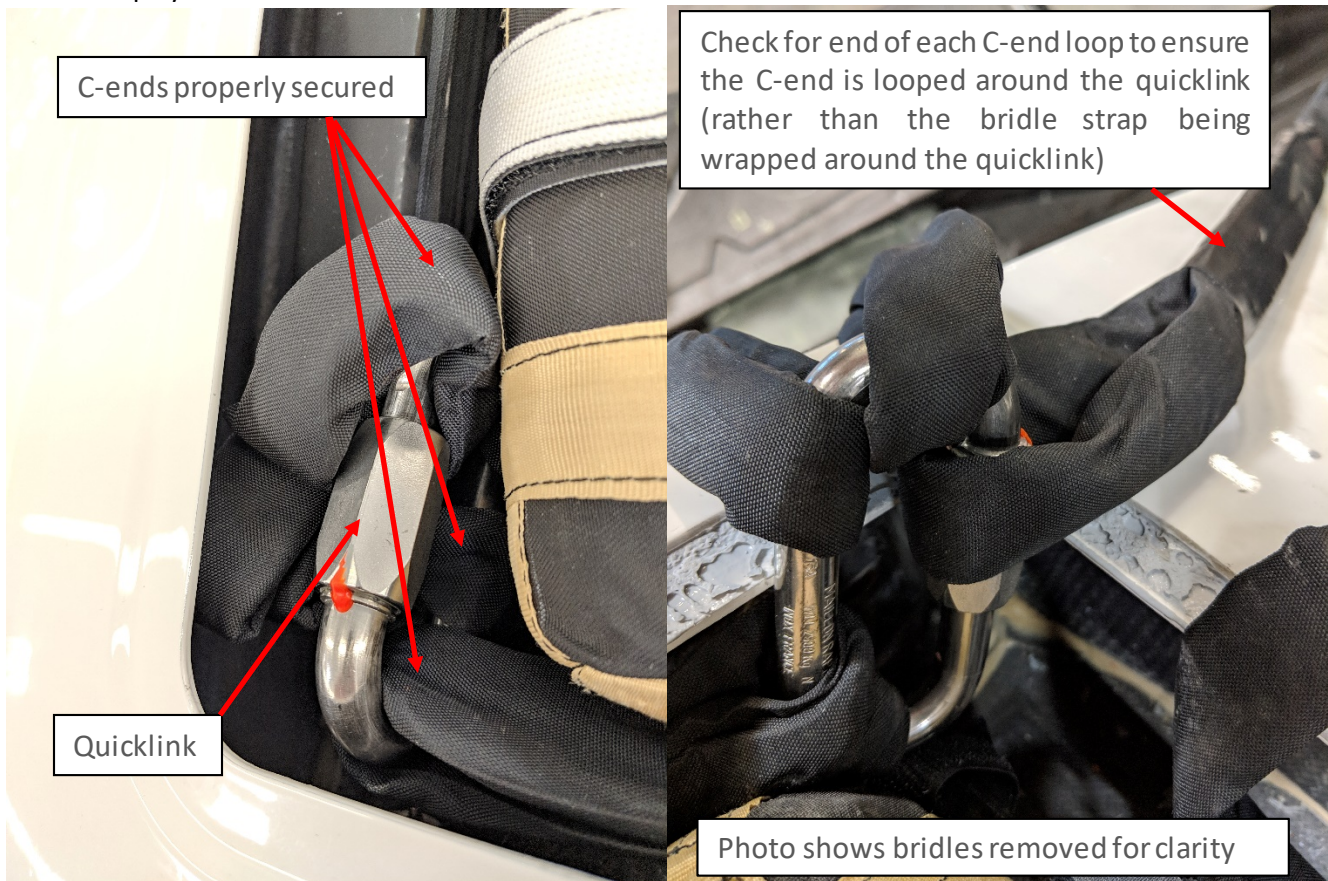
4. Ensure all three C-ends are looped through the quicklink (verification procedure explained in step 5). If bridles are installed incorrectly, the quick link may be connected to a bridle fold rather than the C-end, resulting in one or more of the bridles not being connected to the parachute during deployment.

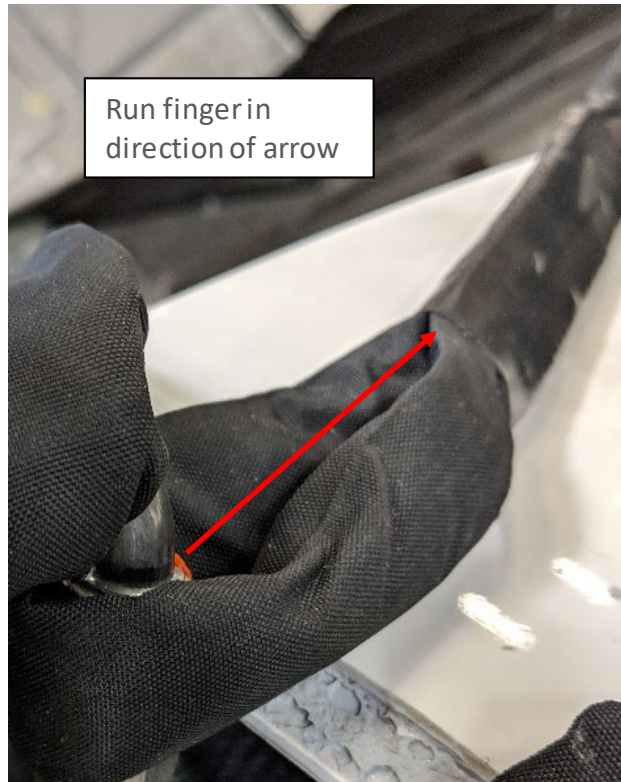
- To verify a C-end loop and not a bridle strap fold is looped through the quicklink, run a finger inside the loop starting from the quicklink down the bridle until the end of the loop is reached (black wrap will hold the two separate sides together, ending the loop). Repeat this until all three bridle C-ends are inspected.

Inspection Result	Following Action
All three C-ends connected to quicklink	Proceed to ' Re-bond IPS egress panel ' section of this Safety Directive/Alert
Any C-end not connected to quicklink	Stop inspection and contact ICON Aircraft for further instruction
Difficult to verify the C-ends are connected due to poor visibility or lack of access	Continue to Steps 7-8

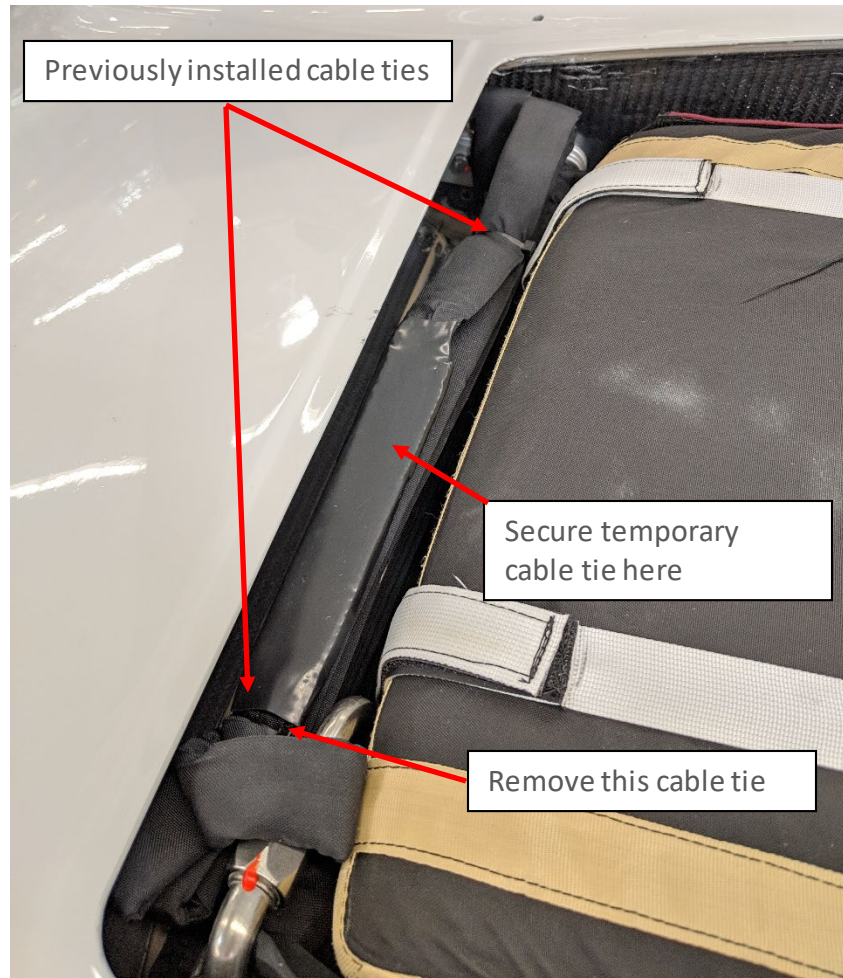
7. Secure center of bridle folded stack with an additional temporary cable tie. Bridle should already have two cable ties installed, one securing either end (this will hold the bridle stack together while a closer inspection can be made).
8. Remove cable tie on right side of bridle (aircraft right, side furthest from fuselage).

Inspection Result	Following Action
All three C-ends connected to quicklink	Reinstall new cable tie to the right-hand side of the bridle (removed in Step 8 of previous section). Remove temporary cable tie in center of bridle (installed in Step 7 of previous section).
Any C-end not connected to quicklink	Stop inspection and contact ICON Aircraft for further instruction
