# SAFETY DIRECTIVE/ALERT

## SD-092122-A

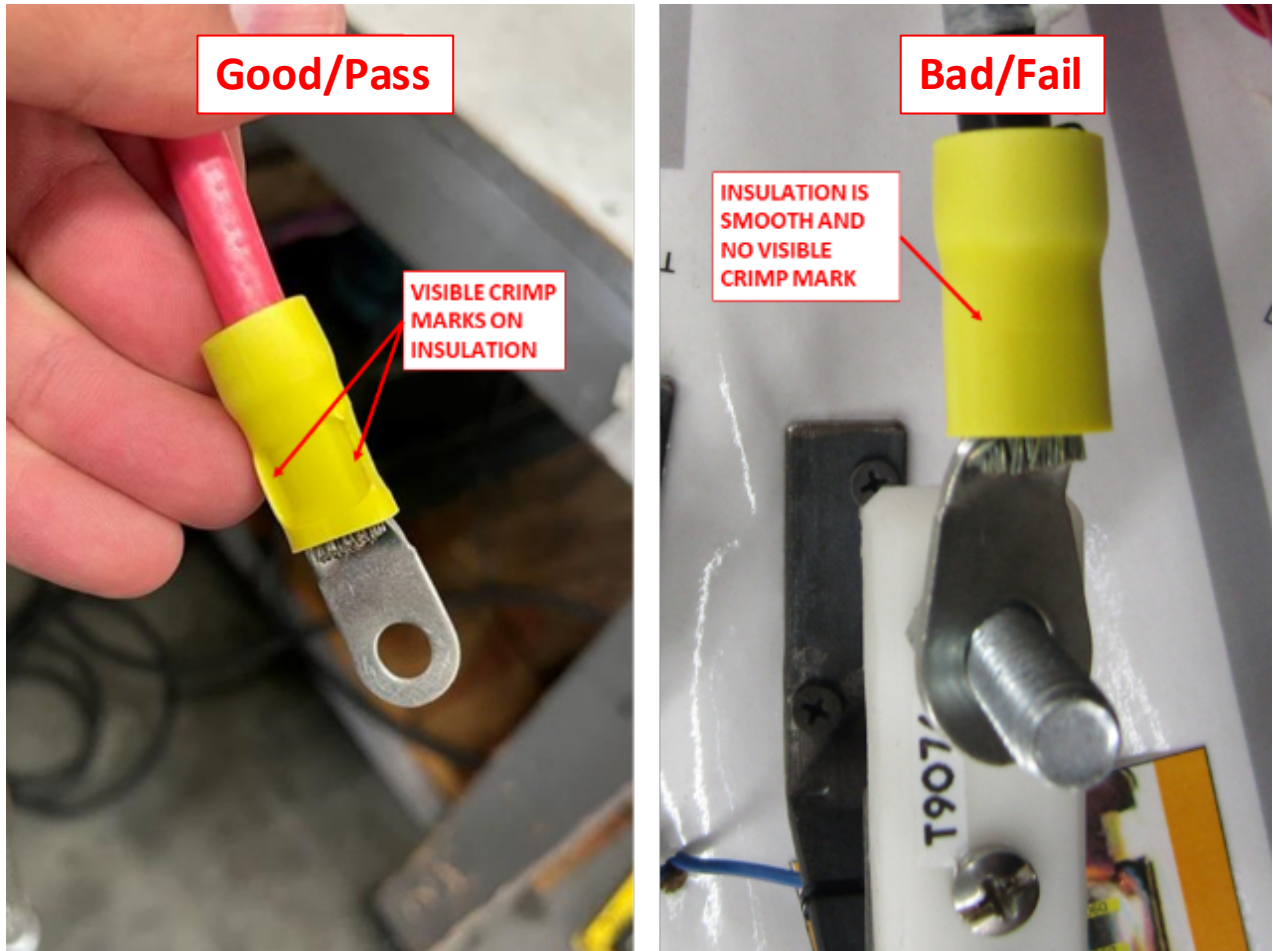
Figure 2 Terminal Inspection Criteria (Good/Pass and Bad/Fail)

**Good/Pass:** Visual crimp marks seen on insulation

**Bad/Fail:** Insulation is smooth and no visible crimp marks

- a. If the terminal crimps are found to be Good/Pass, then no action is required for the specific terminal.
- b. If a terminal crimp is found to be Bad/Fail, re-crimp or replacement of the failed terminal is required. Refer to Section C “Crimping Instructions” below.

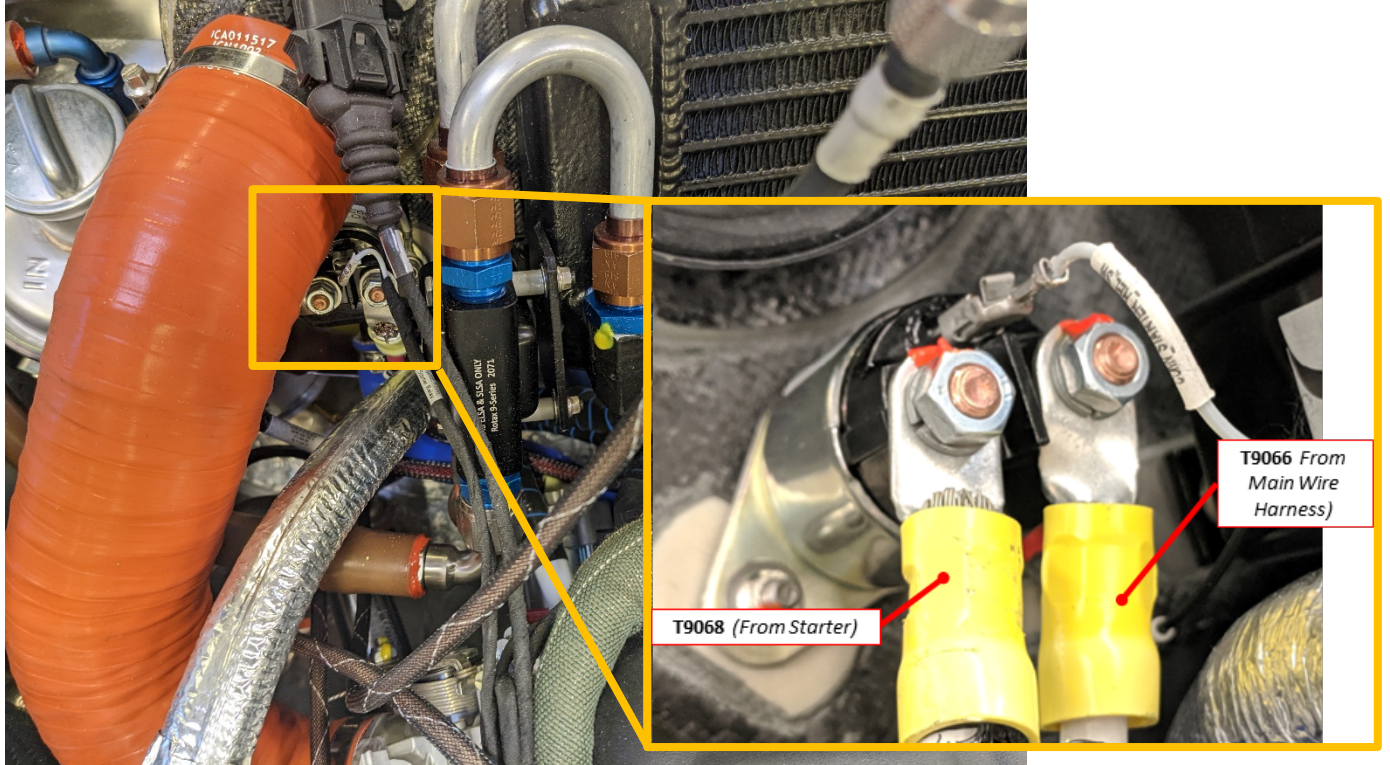
Figure 3 Starter Solenoid (T9068 & T9066)

- i. T9066 (Connected to RH terminal of the Starter Solenoid) See Figure 3
- ii. T9068 (Connected to LH terminal of the Starter Solenoid) See Figure 3
- iii. T9075 (Connected to Lower FWD Engine block GND) See Figure 4
- iv. T9067 (Connected to Engine Starter Motor) See Figure 5

3. Once all affected terminals are re-crimped or replaced, re-install each terminal using the following instructions:
  - a. **T9066** and **T9068**:
    - i. Connect electrical connections to starter relay with retained hardware, see Figure 3.

- ii. Using isopropyl alcohol, clean surfaces where thread locker will be applied. Apply LOCTITE 243 to threads of nuts.
    - iii. **T9068** ring terminal **from starter** to **LH ring terminal** on **starter relay** as shown with supplied hardware see Figure 3.

- iv. **T9066** ring terminal **from main wire harness** to **RH ring terminal** on **starter relay** as shown with supplied hardware see Figure 3.

- v. Torque hardware to 33-39 in-lbs.
    - vi. Verify installation is complete.
    - vii. Verify wire harness is at least 0.5 inches from sharp edges/corners on plenum box.

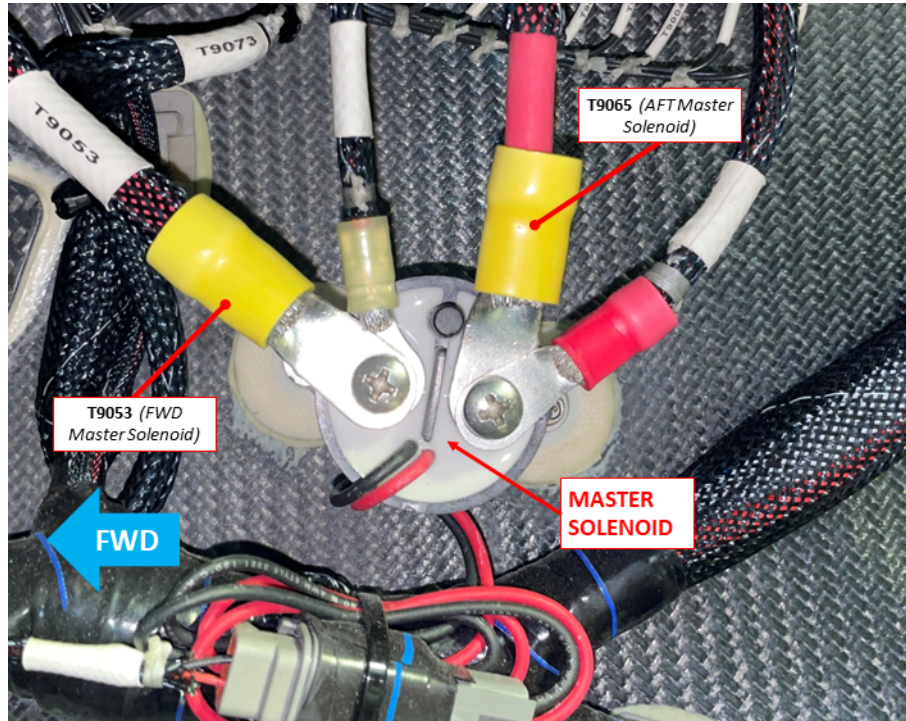
Figure 6 Aircraft Master Solenoid (T9053 & T9065)

- i. T9053 (FWD Master Solenoid) Reference Figure 6
- ii. T9065 (AFT Master Solenoid) Reference Figure 6
- iii. T9054 (Positive Battery Terminal) Reference Figure 7

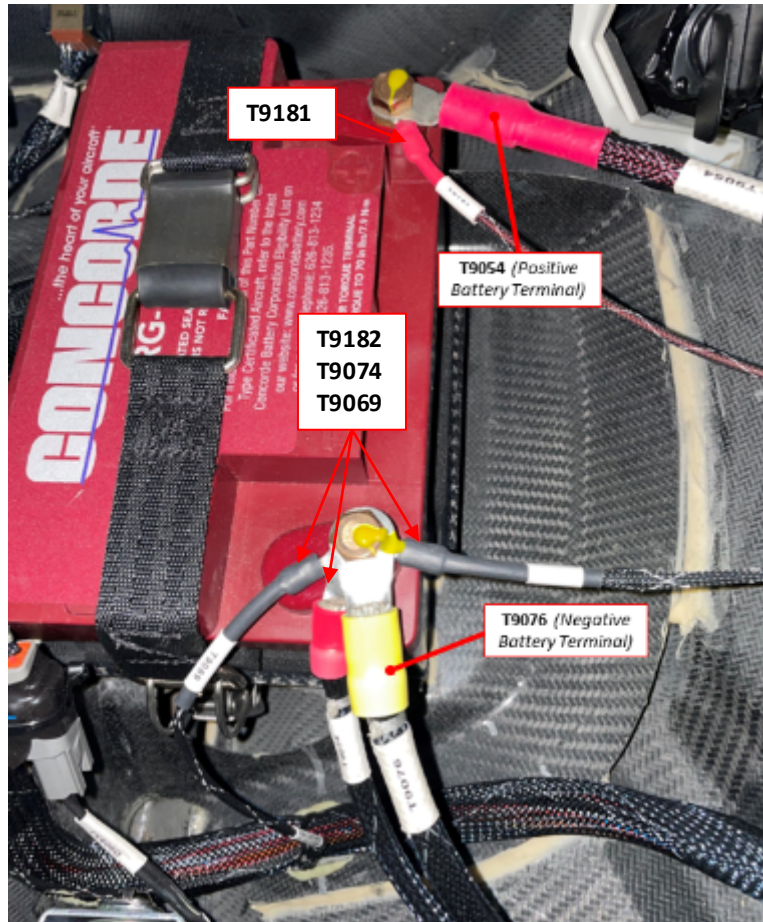
Figure 7 Battery (T9054 &amp; T9076)

- iv. T9076 (Negative Battery Terminal) Reference Figure 7

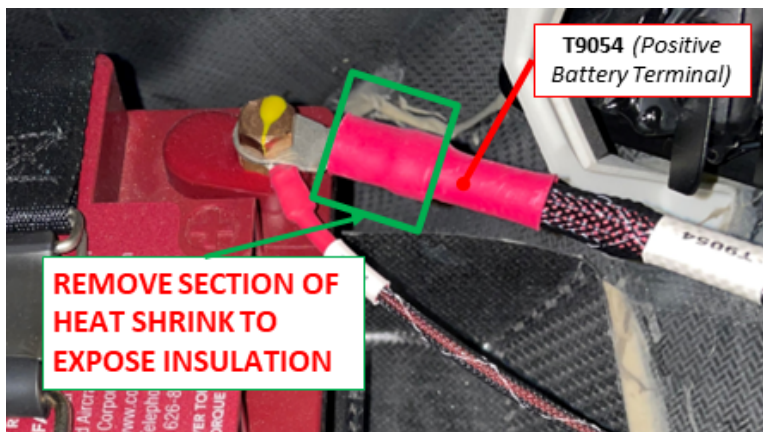
Figure 8 T9054 Heat Shrink

**NOTE:** The insulation T9054 may have heat shrink impeding the inspection. It is permissible to carefully cut away the heat shrink. Reference Figure 8
