SAFETY DIRECTIVE/ALERT

SD-100421-A

DATE ISSUED: 10/4/2021
DATE EFFECTIVE: 10/4/2021
SUBJECT: Non-Conforming Fuel Pressure Relief Blocks
AIRCRAFT AFFECTED: **MODEL:** A5
S/N: 00056 - 00074, 00076-00135, 00137-00139, and 00142
REQUIRED ACTION: Inspect fuel pressure relief block. Replace if non-conforming.
TIME OF COMPLIANCE: Prior to next non-ferry flight. Up to 10 hours of ferry flight by owner allowed to facilitate delivery to an ICON Service Partner.
REVISION HISTORY N/A

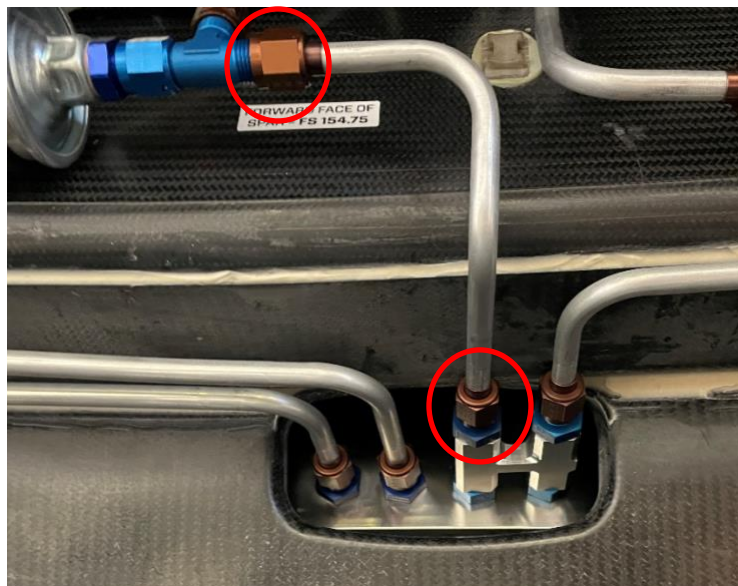
- 1) Remove headliner per maintenance manual (ICA000833, Issue C5) section 3.6.2.1.
- 2) Set fuel shut-off valve to "ON" to allow any fuel in the lines to drain to the tank
- 3) Loosen fuel block supply line. Make sure to capture any fuel that drains from the lines using an appropriate fuel absorbent material.

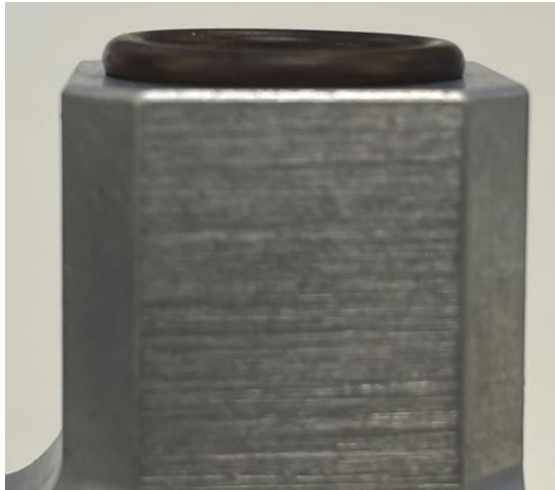
1. Carefully remove the O-ring, and place it back in the fuel block
2. If the O-ring fits snugly then the fuel block is conforming

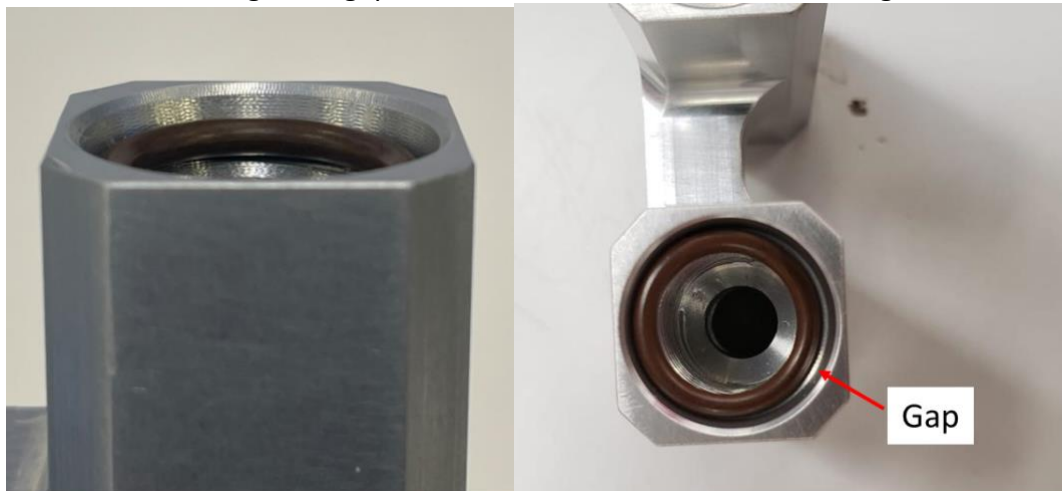
3. If the O-ring has a gap, then the fuel block is non-conforming

If Non-Conforming - FUEL BLOCK REPLACEMENT

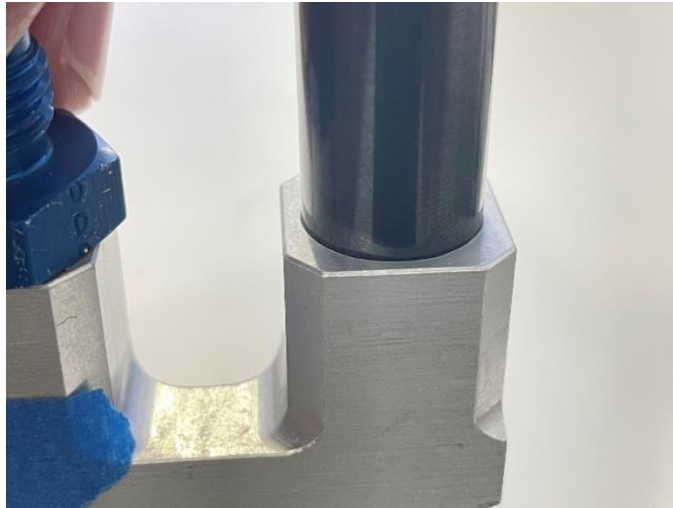
1. Measure the O-ring sealing surface using either calipers or a 5/8 dowel or gauge pin (dowel must not have taper on the end). Place the dowel into the O-ring gland (with O-ring removed).
2. If the dowel rests on the initial face or slightly sub flush, then the fuel block is conforming.

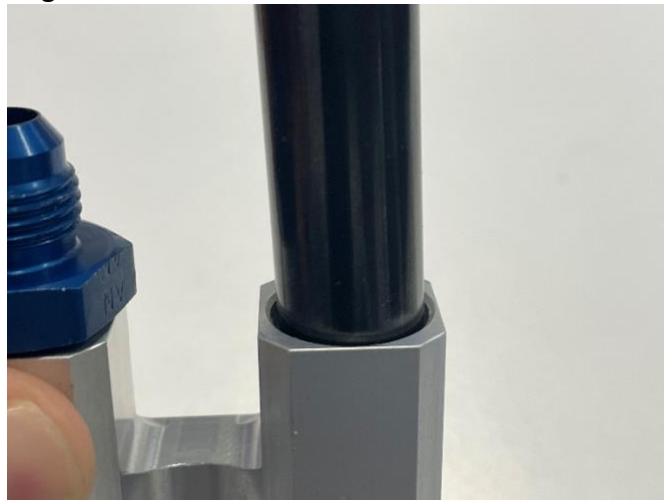
3. If the dowel can be placed into the O-ring gland, then the fuel block is non-conforming.
